Advanced Corrosion Principles and Control (Part 1)

- Stray Current Corrosion
- Corrosion Surveying Considerations in Freshwater

David Rifkin (Part 1)

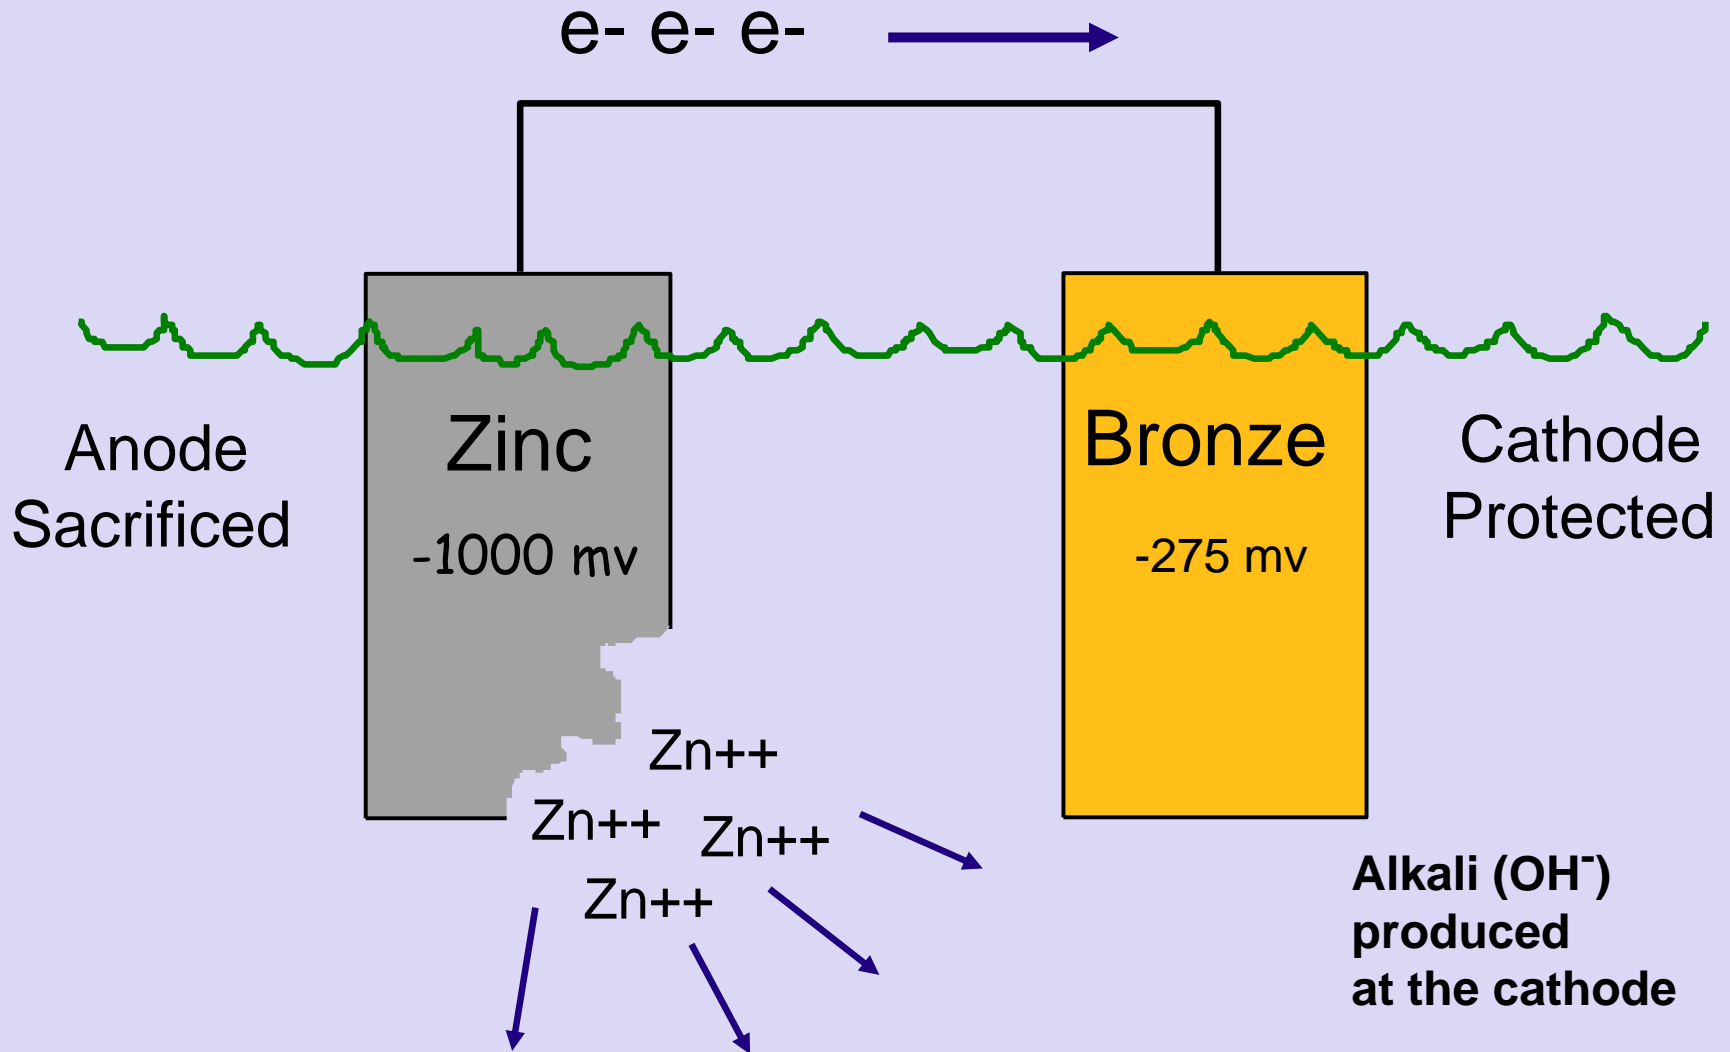
Basic Galvanic Cell

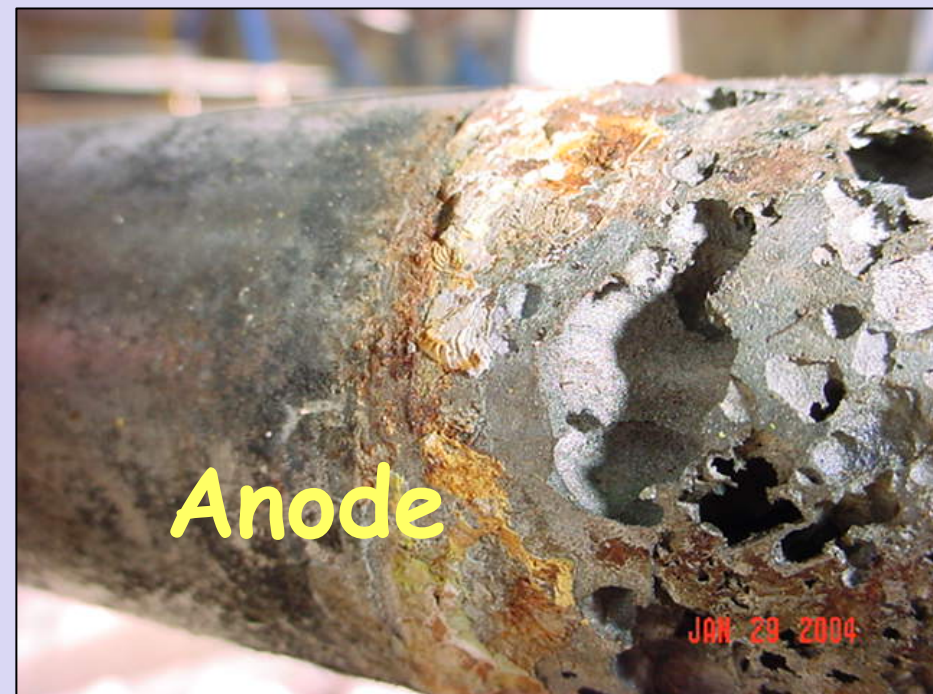
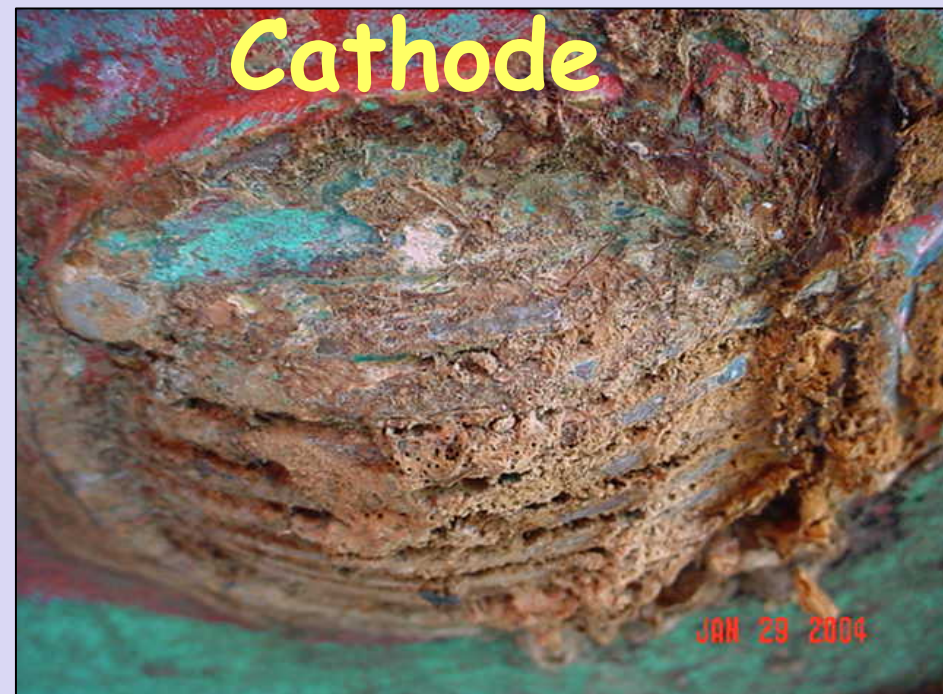
- Remember, this can happen real fast.
- Trawler with fault in AC/DC refrigerator and bonding system faults.

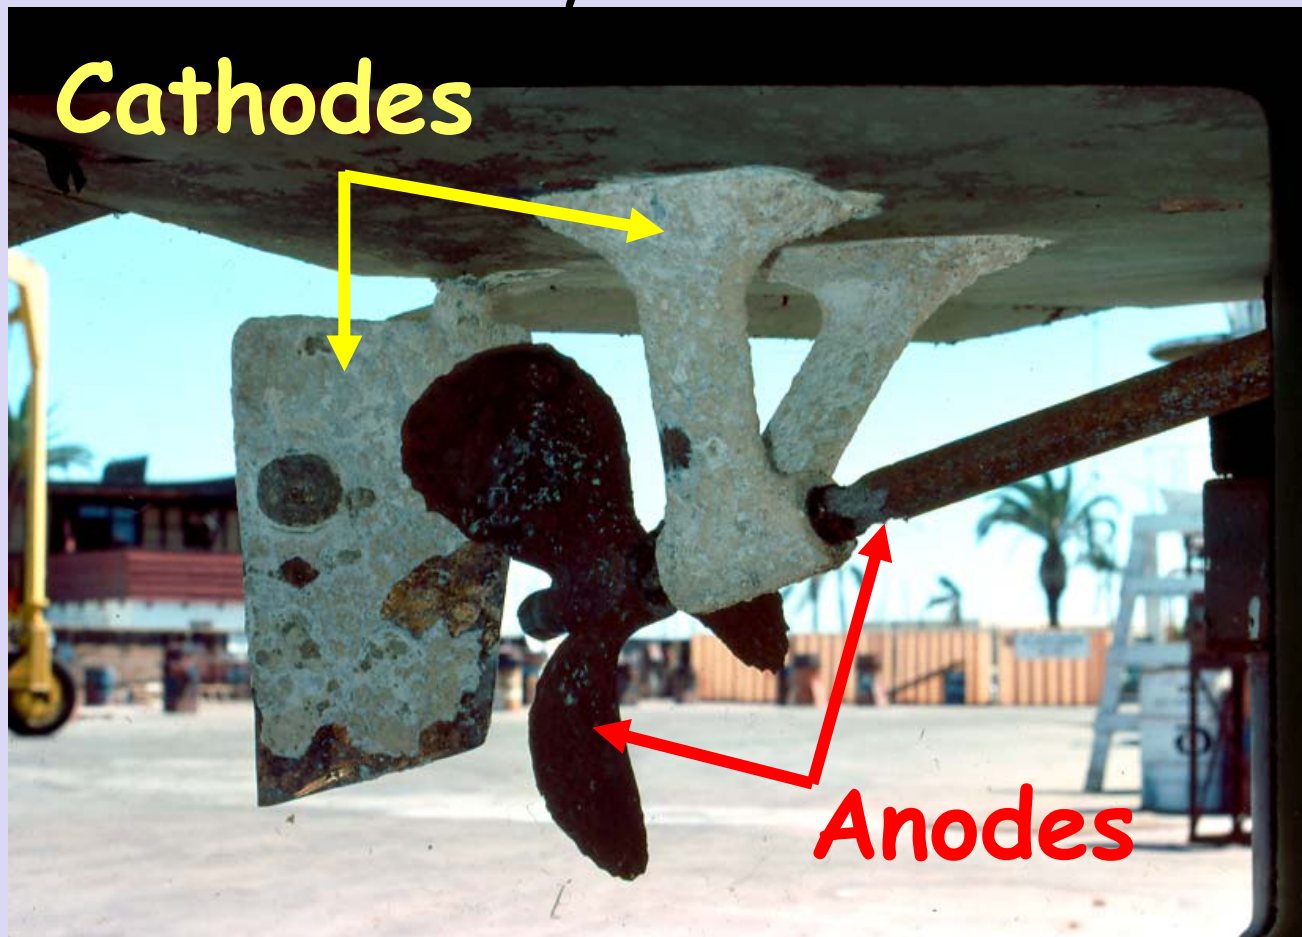
- Classic appearance.
 - Calcium precipitated onto the cathode, while the anode corroded...why?

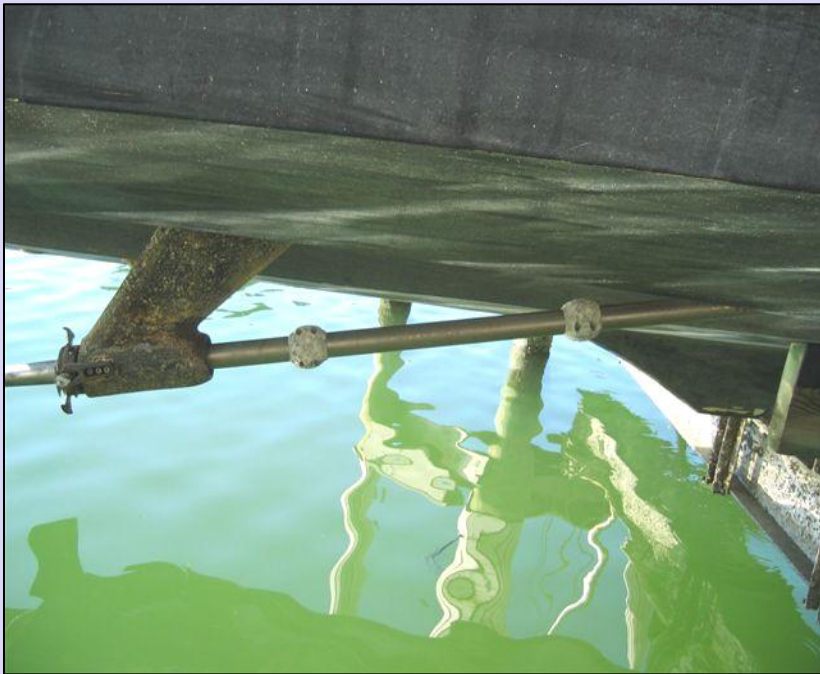
- Sportfish with 2 faults
 - Alternator ground fault to engine block
 - Ungrounded ("isolated") engine block
 - Damaged in 8 hours

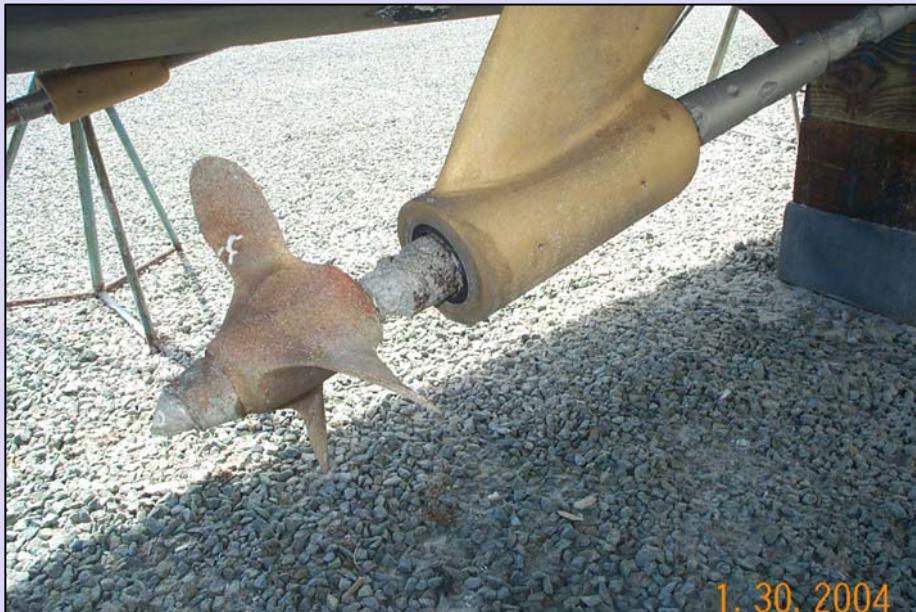
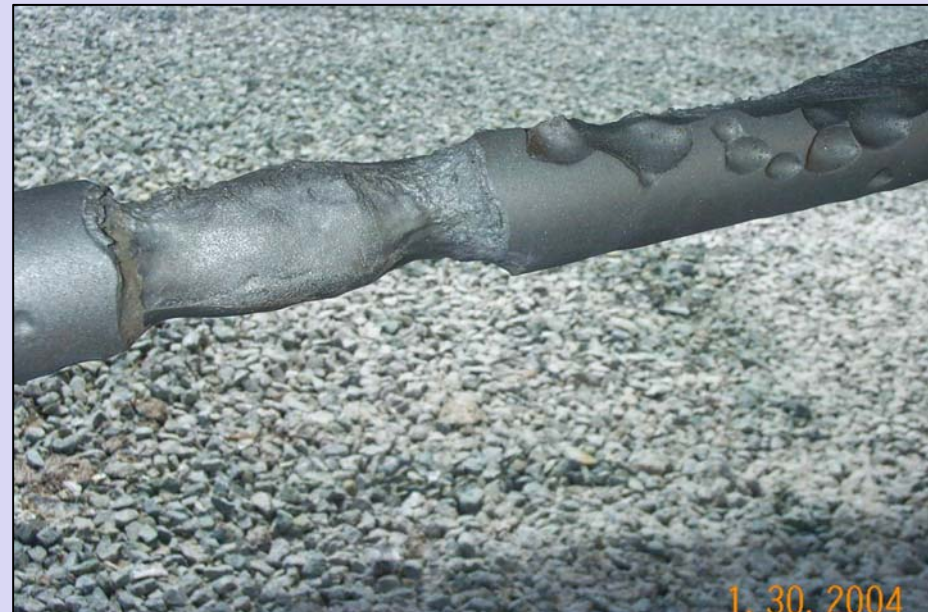
- Another Sportfish with 2 faults
 - Starter positive to solenoid case
 - Ungrounded ("isolated") engine block
 - Estimated damaged in weeks

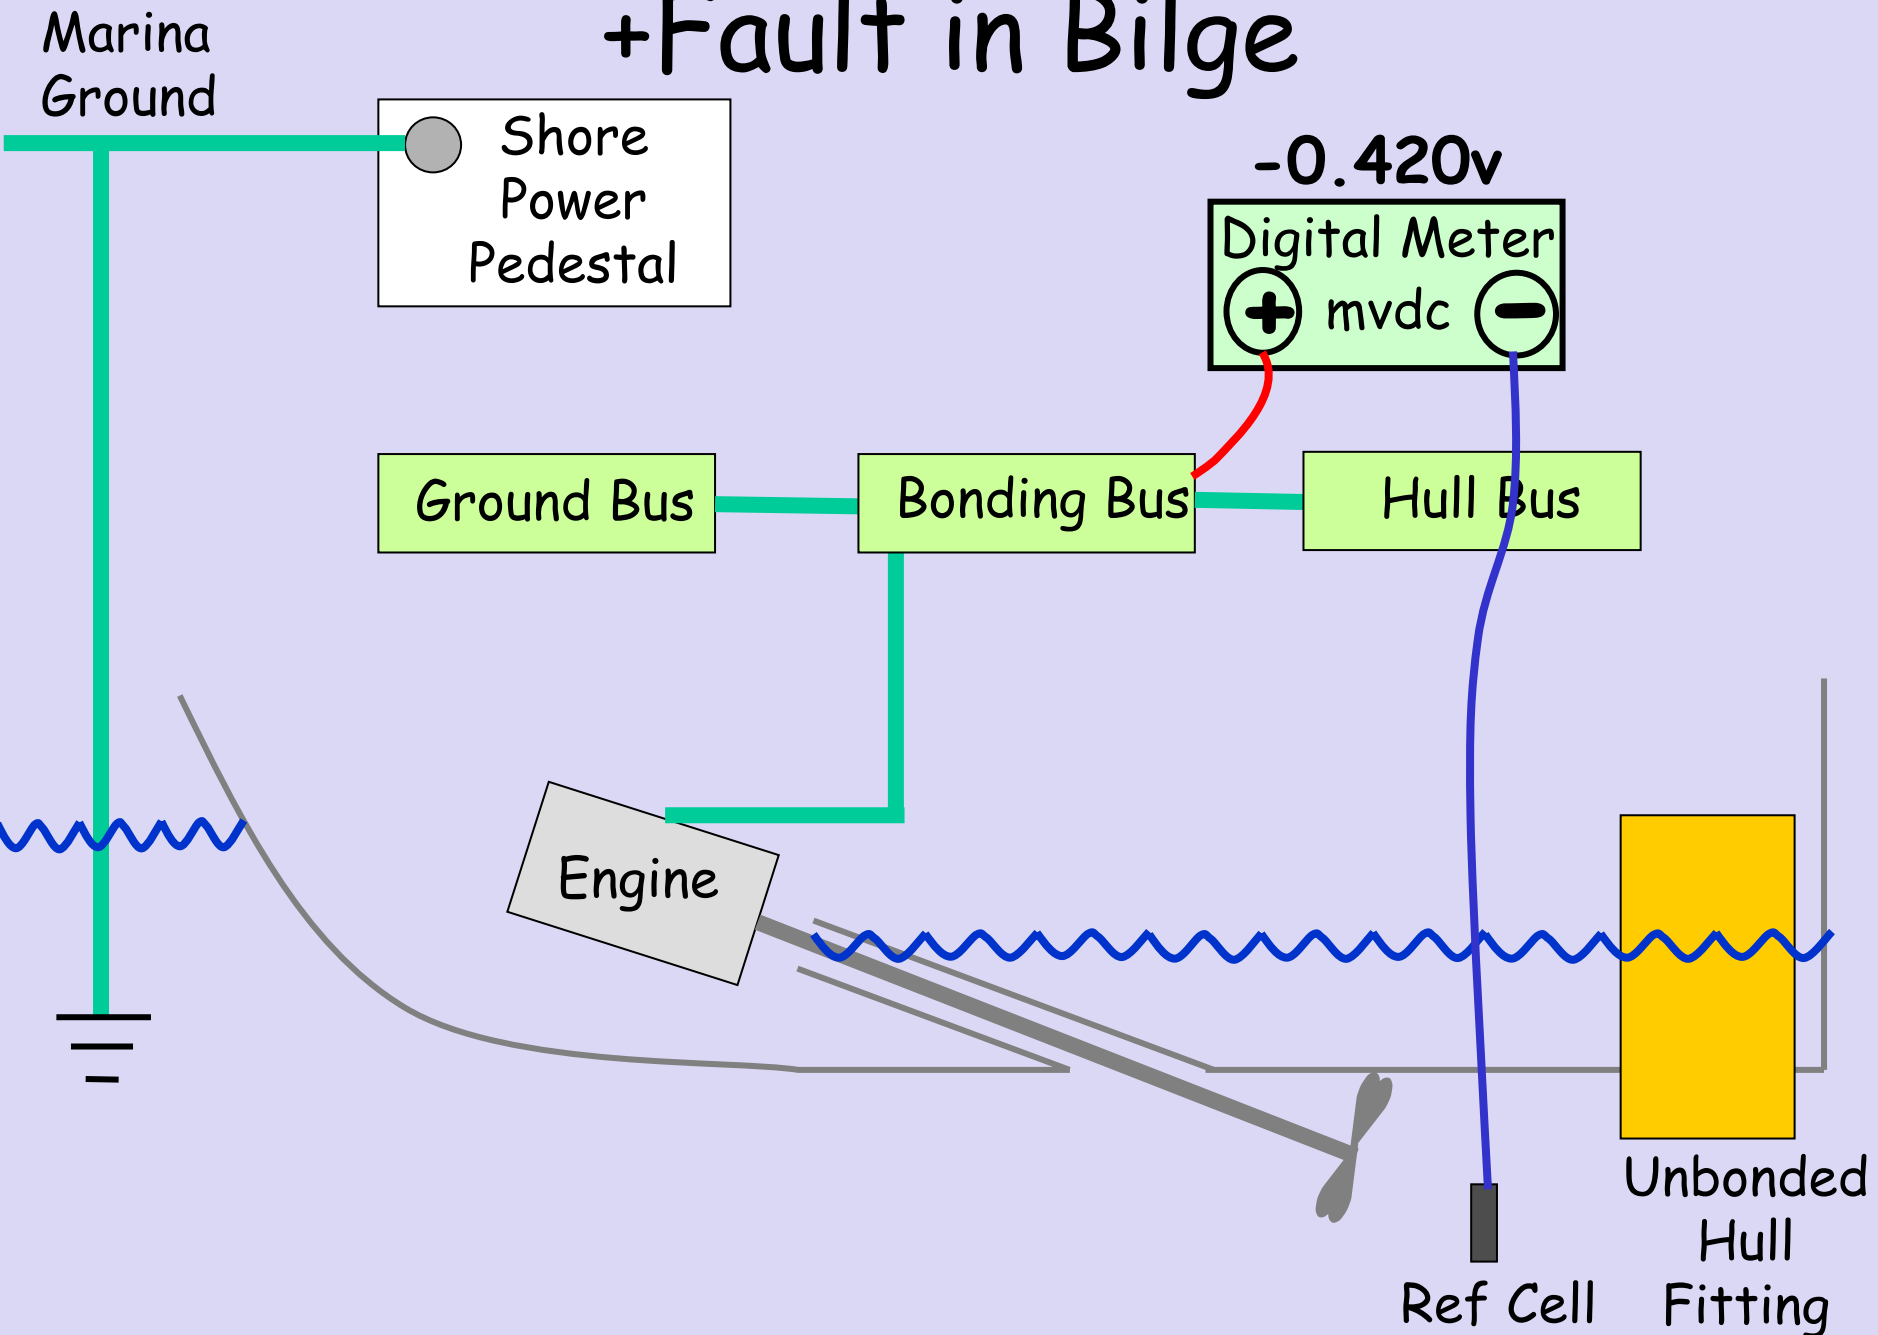
+Fault in Bilge

- Two or more metals in the same electrolyte existing at different potentials connected to a common source (the “holy grail” of understanding).
- This establishes a path for current to flow (electrons in metals, ions in the electrolyte).
- Typically there is an **electrical ground fault along with a bonding problem** (on the boat with the actual fault).
- Let's analyze some scenarios, schematically.

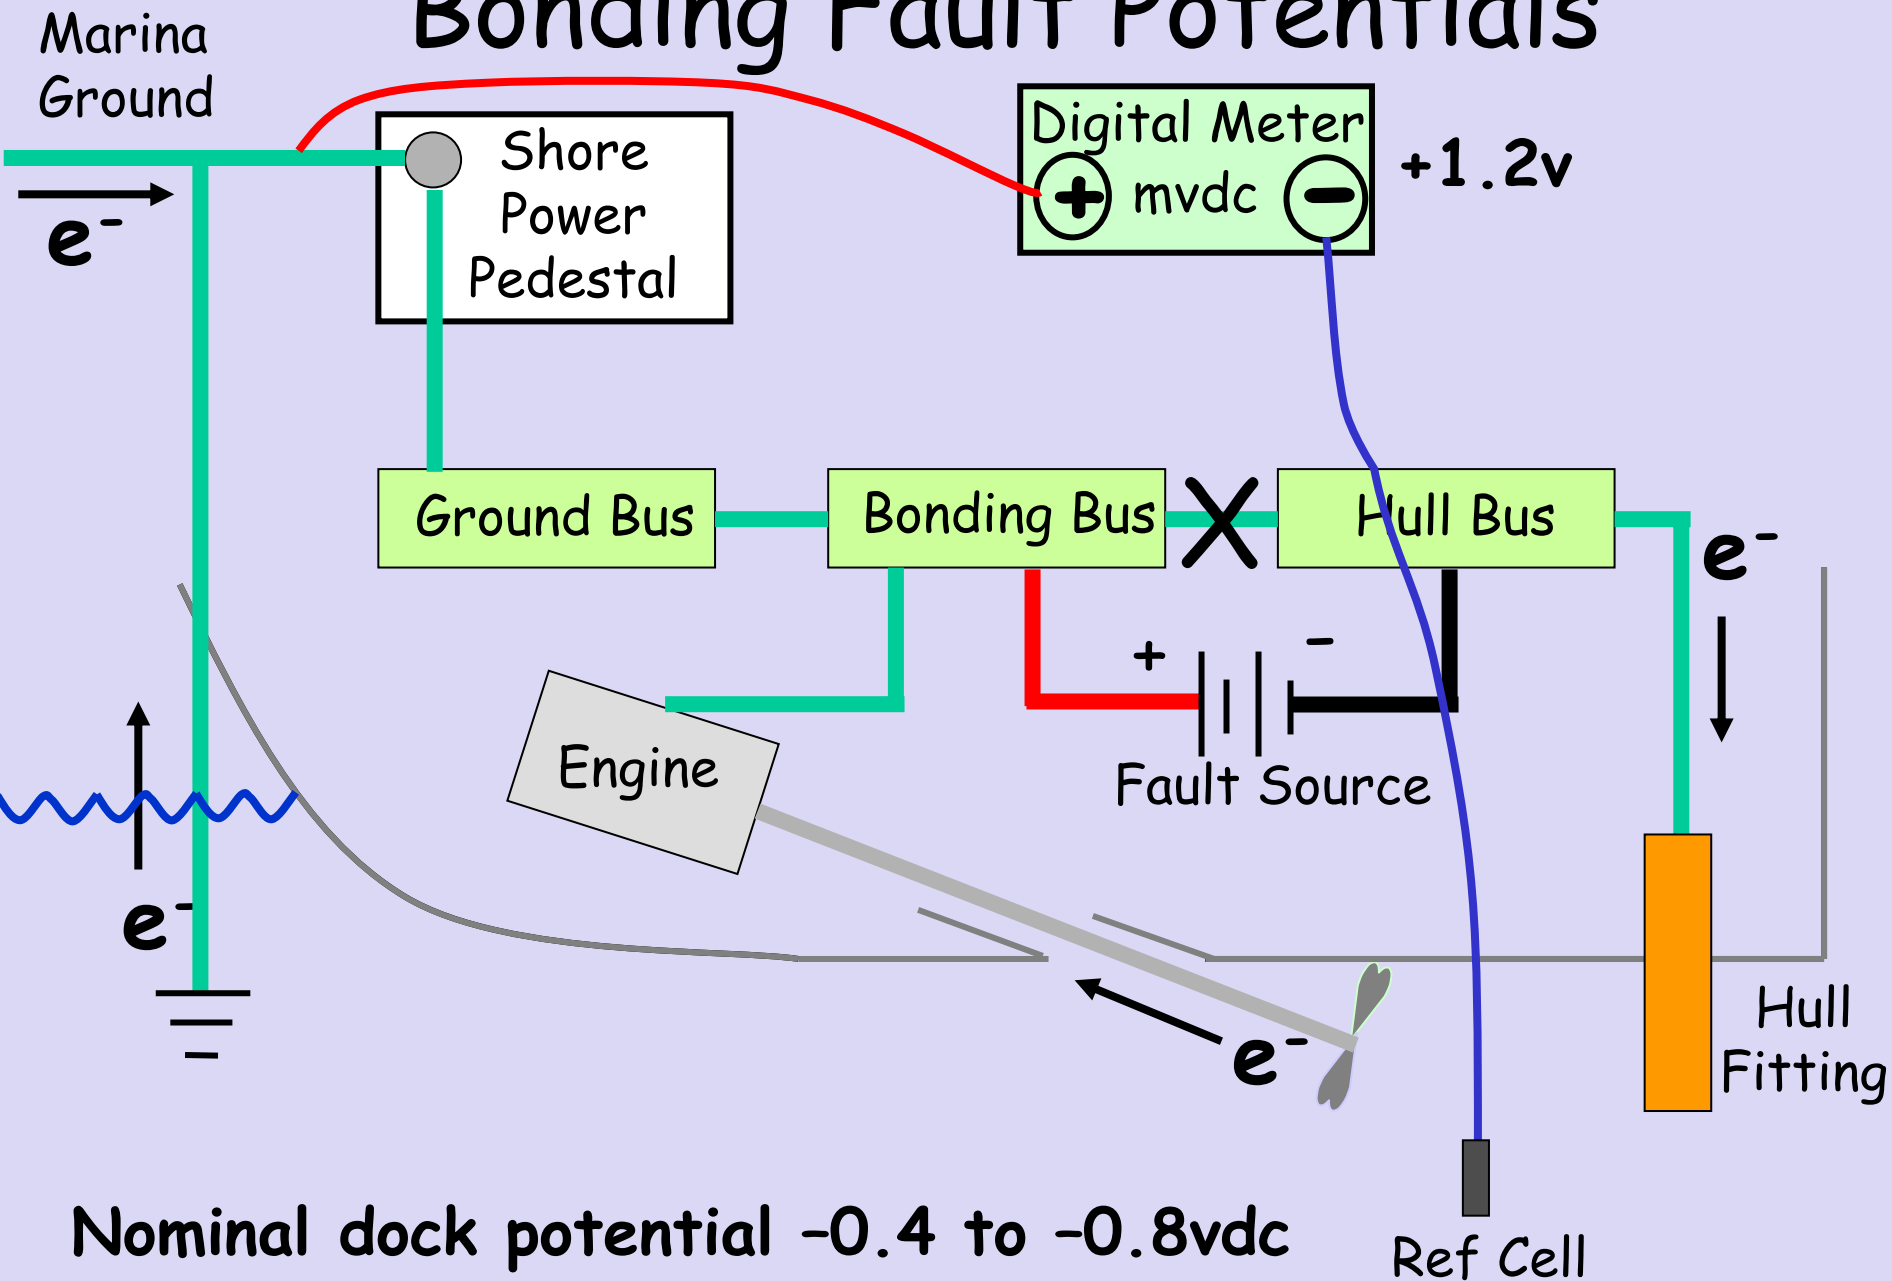
Bonding Fault Potentials

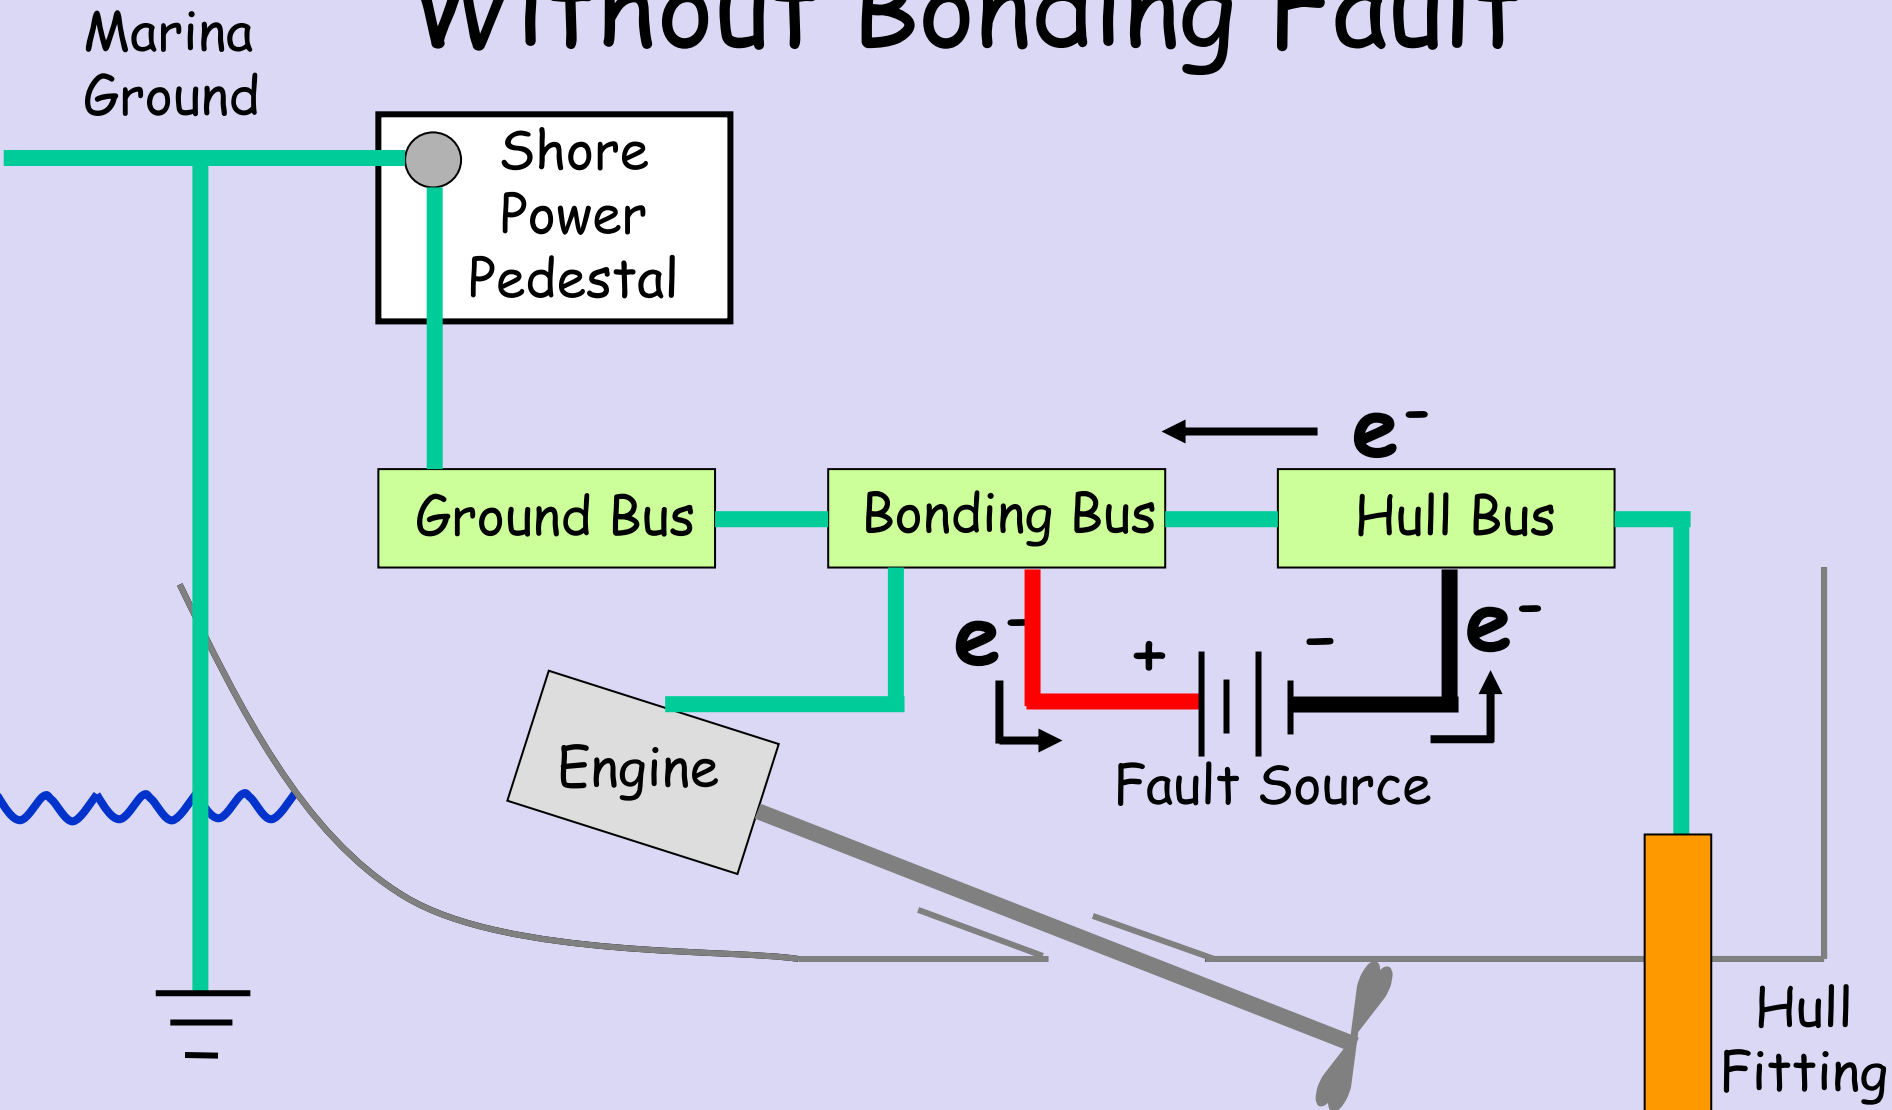
Without Bonding Fault

**All U/W Fittings at Same Potential
Stray Current Corrosion STOPS!**

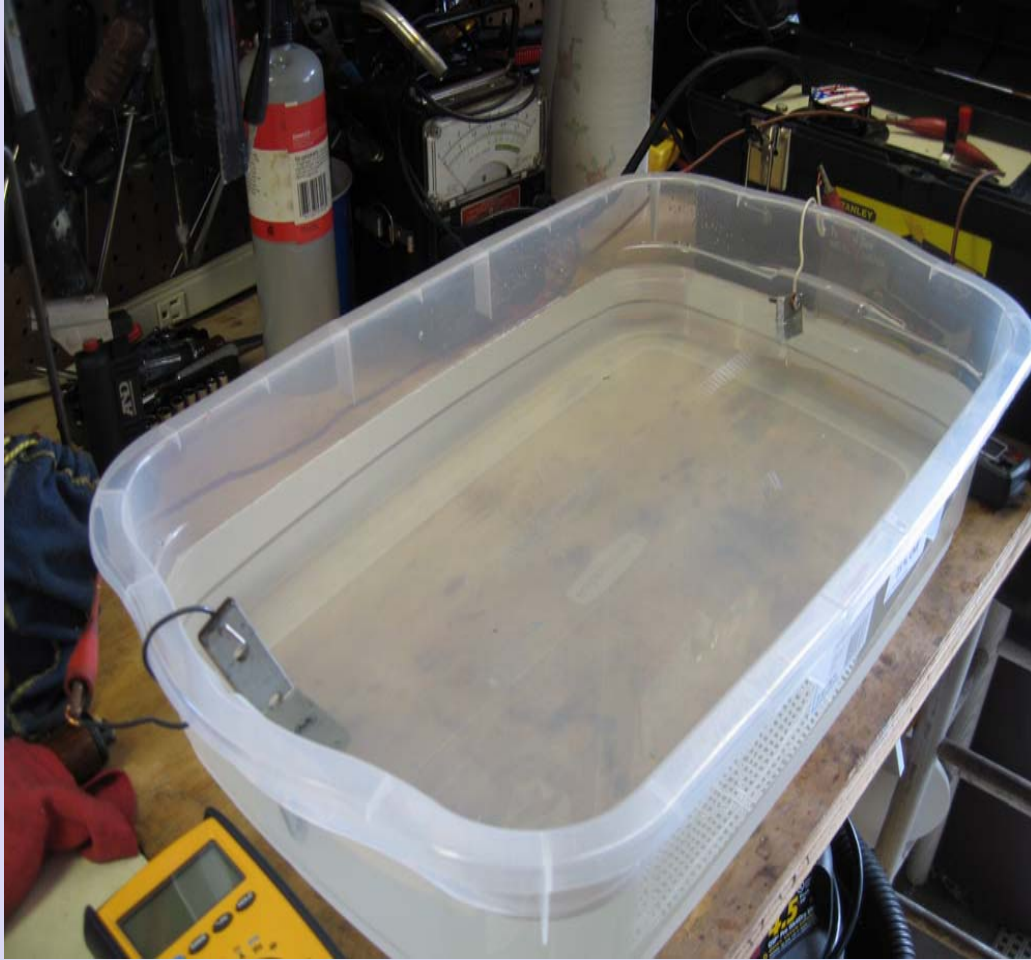
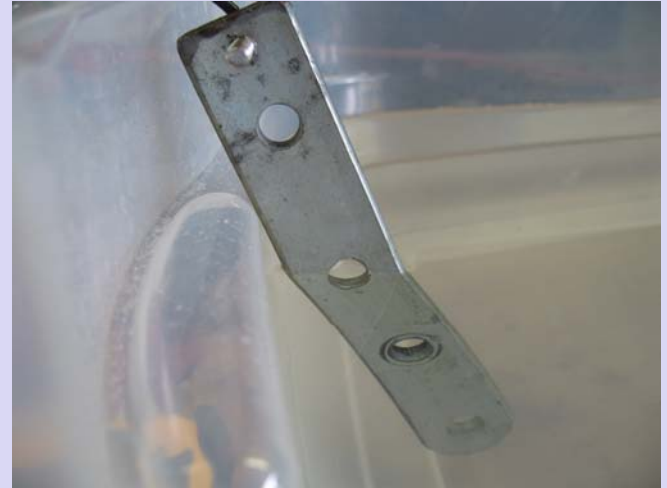
Test Setup

- A study done by James Williams , Northern States Power Company (Feb 1966) showed that **AC will cause about 40% of the damage as a like amount of DC will cause in aluminum.**
- In iron, copper, and lead, the same AC current will cause only about **1% of the damage** caused by DC current.
- Look at the pictures from our own experiments which support the above finding.
 - The painted surface was undamaged at low densities.

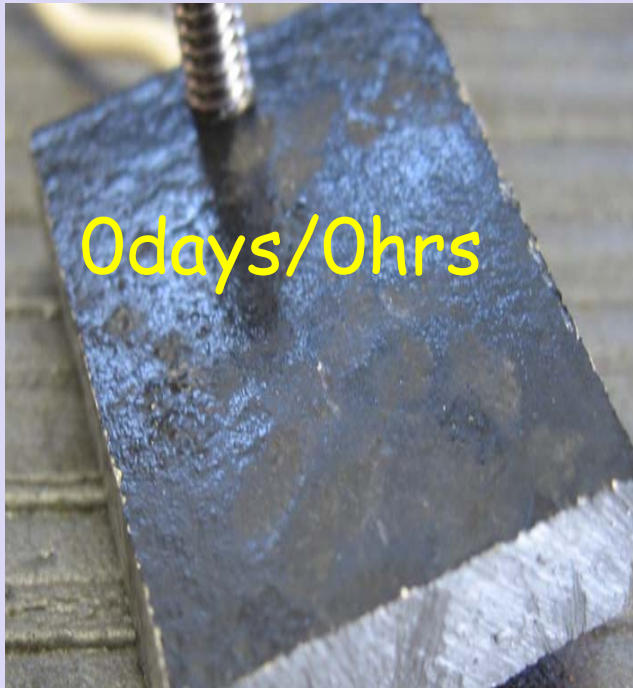
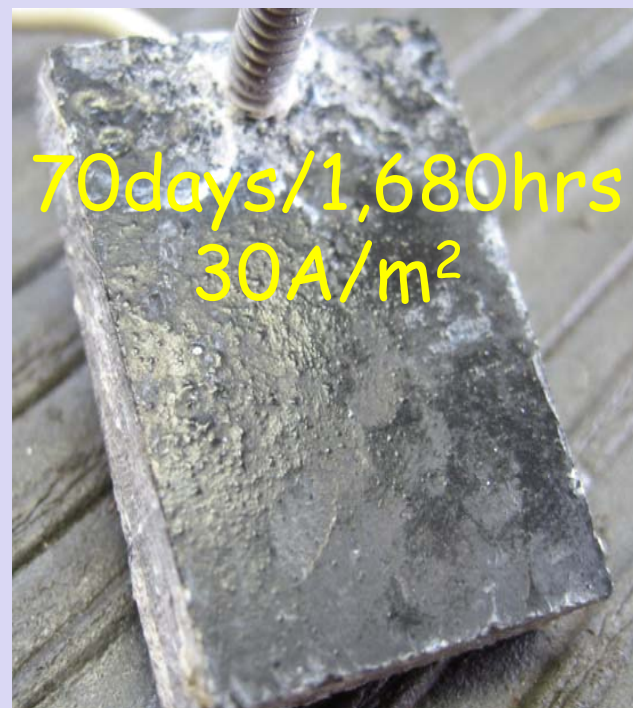
165hrs
300A/m²

Painted Face

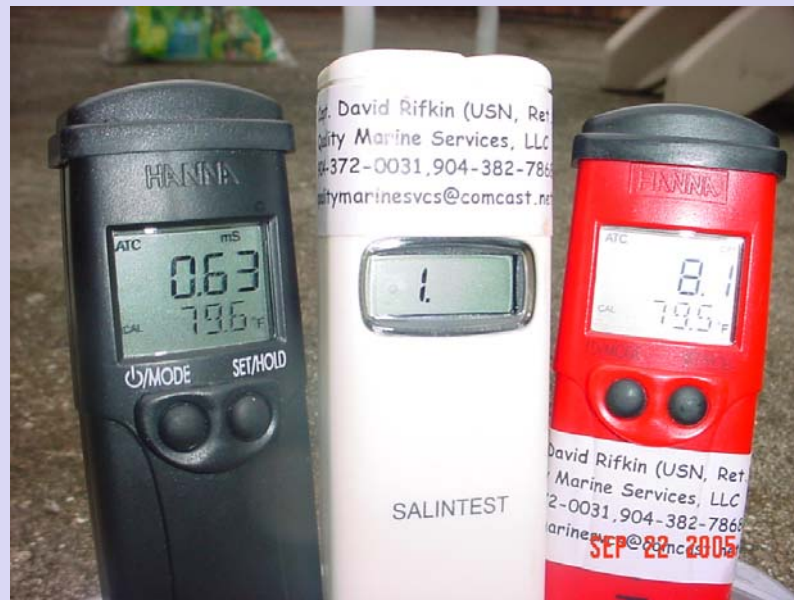
- Ted Swartz uses a zinc reference cell for both fresh and saltwater applications. I am currently testing one of these.
- **Some other tools you can use...**
 - Conductivity meter (saltwater 50ms/cm, tap water 0.2-0.6ms/cm)
 - Salinity meter
